**Accident Investigation Report**  
**Underground Coal Mine**

**Electrocution Fatality Investigation Report**  
**January 24, 2002**

**Mackie J. Coal Company, Inc.**  
**Mine No. 4**  
**Mine Index No. 12681AE**  
**Buchanan County, Virginia**

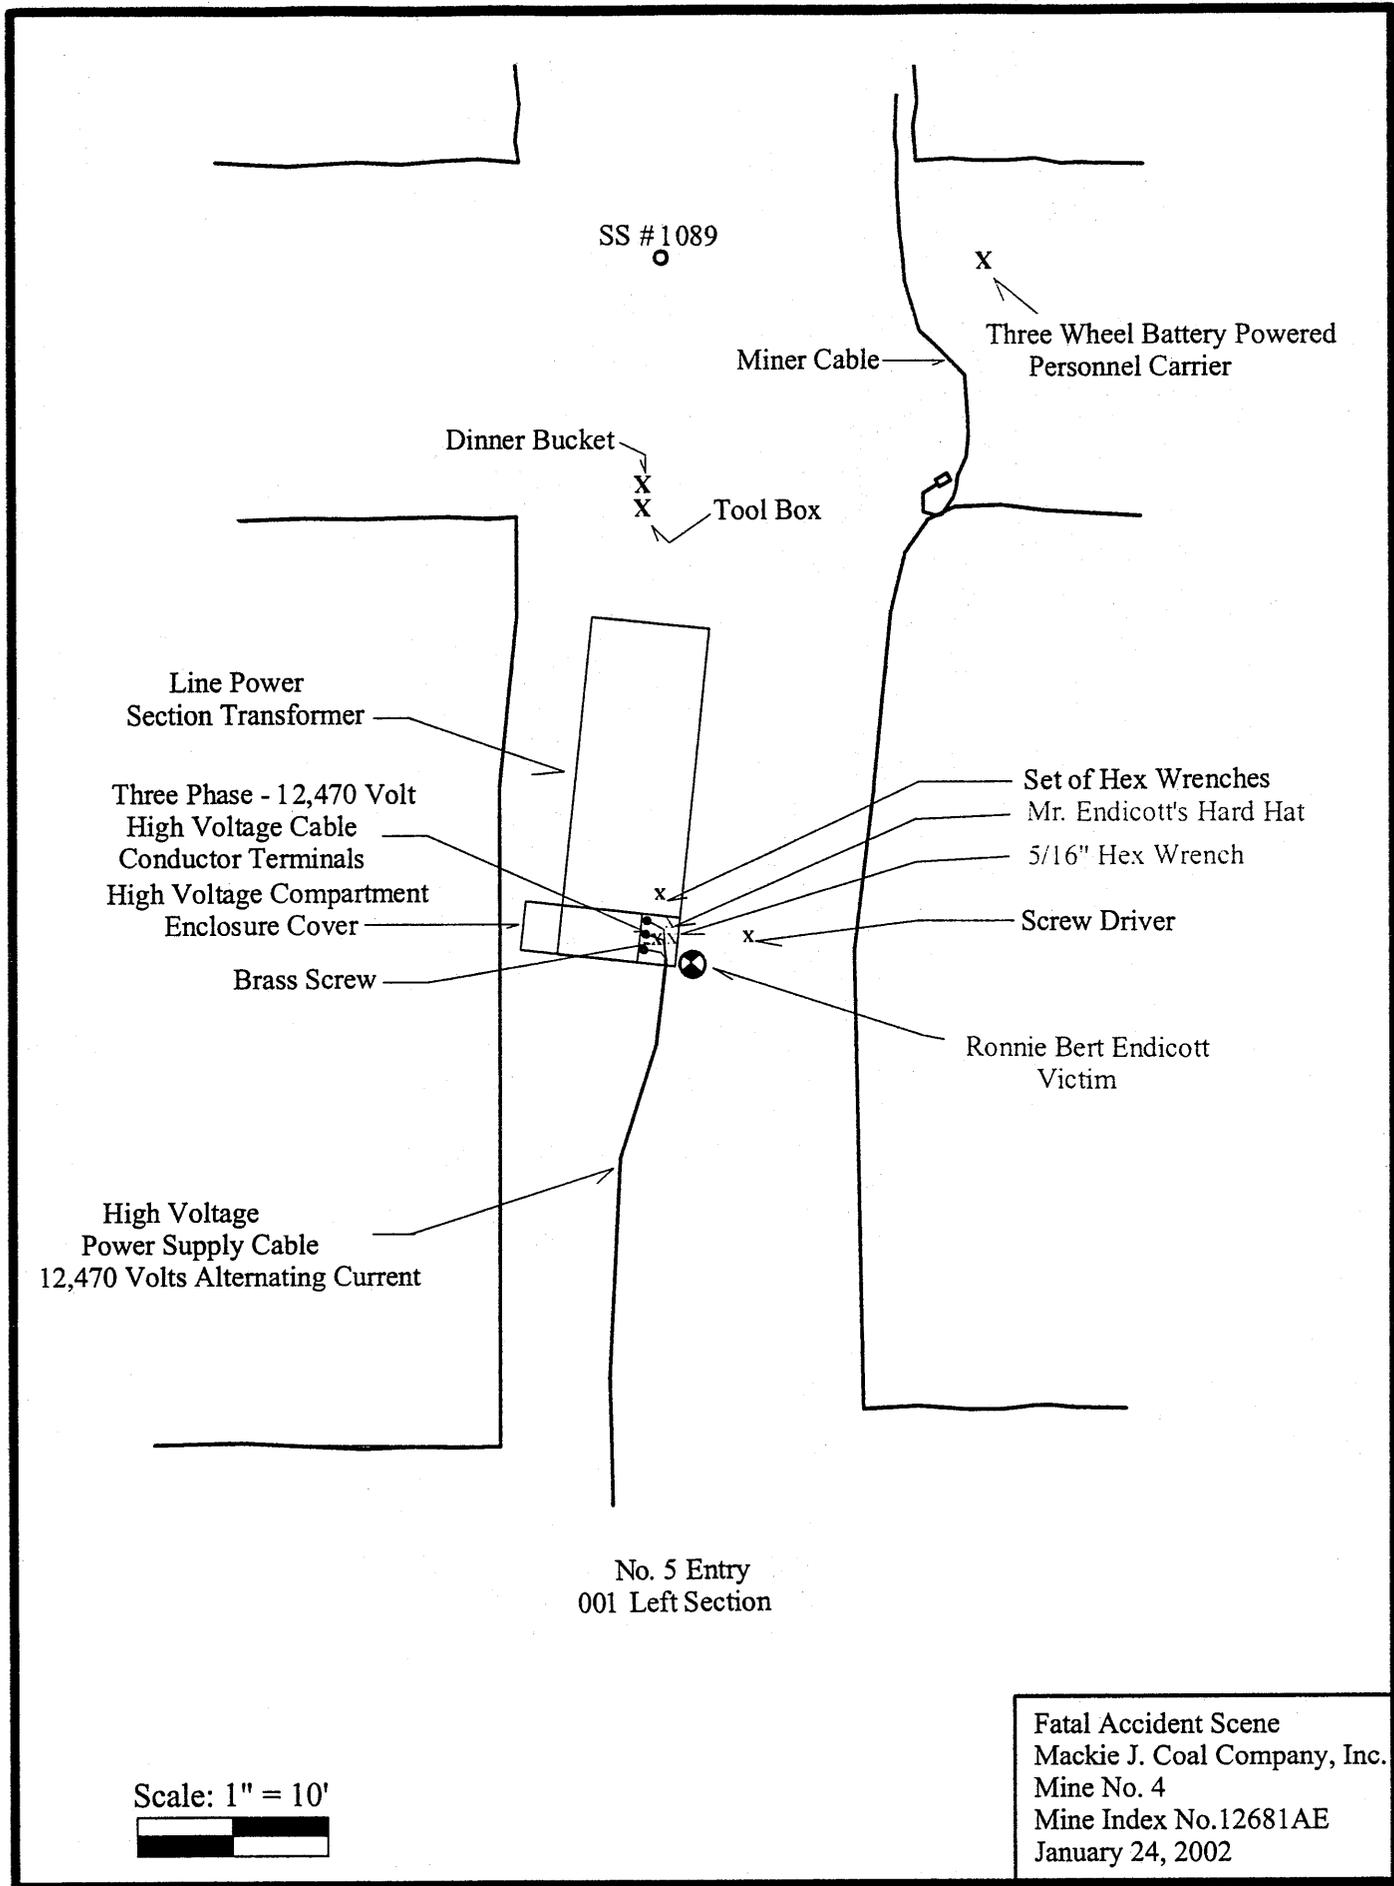
**Fatal Accident Scene  
Mackie J. Coal Company, Inc.  
Mine No. 4  
M.I. No. 12681AE  
January 24, 2002**

1. The electrical accident occurred in the No. 5 entry on the 001 Left Section transformer located approximately 36 feet outby survey station No. 1089.

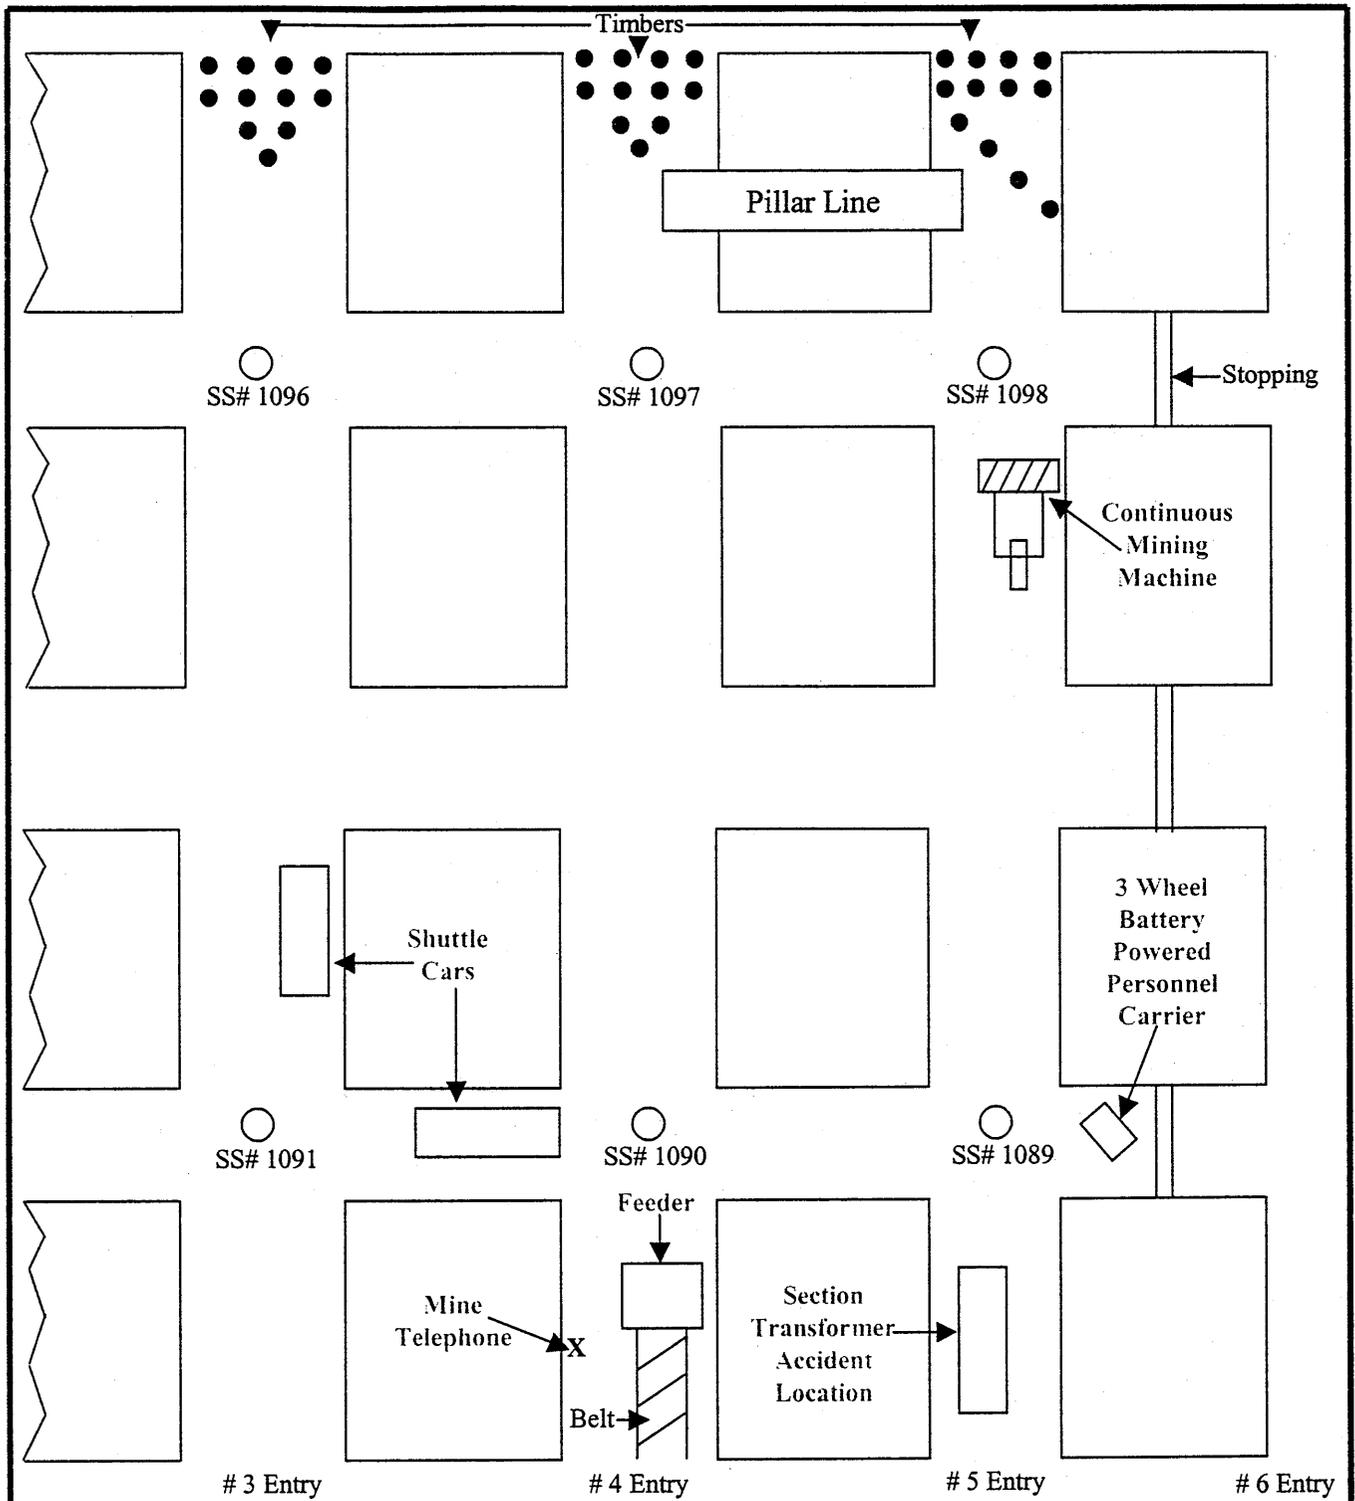
Fatal Accident Scene  
Mackie J. Coal Company, Inc.  
Mine No. 4  
M. I. No. 12681AE  
Section - Equipment Map  
January 24, 2002

5. The Joy continuous mining machine was located in the No. 5 entry on the 001 Left Section approximately 125 feet inby the section transformer.
6. The 001 Left Section transformer, model 600 PC, serial No. 6055 was manufactured by Line Power and was rated at 600 KVA. The section transformer was provided with an input of 12,470 volts alternating current and utilized step-down transformers to provide 995, 600 and 480-volt circuits to provide electrical power to section equipment. All high voltage cables installed in the mine from the surface substation to the section transformer were No. 2 AWG-15 KV cable.
