COMMONWEALTH OF VIRGINIA  
DEPARTMENT OF MINES, MINERALS AND ENERGY  
DIVISION OF MINES

DOUBLE R COAL COMPANY, INCORPORATED  
MINE #1  
MINE INDEX NUMBER 11427AA

INVESTIGATION REPORT  
(Underground Coal Mine Explosion)

**December 26, 1987**

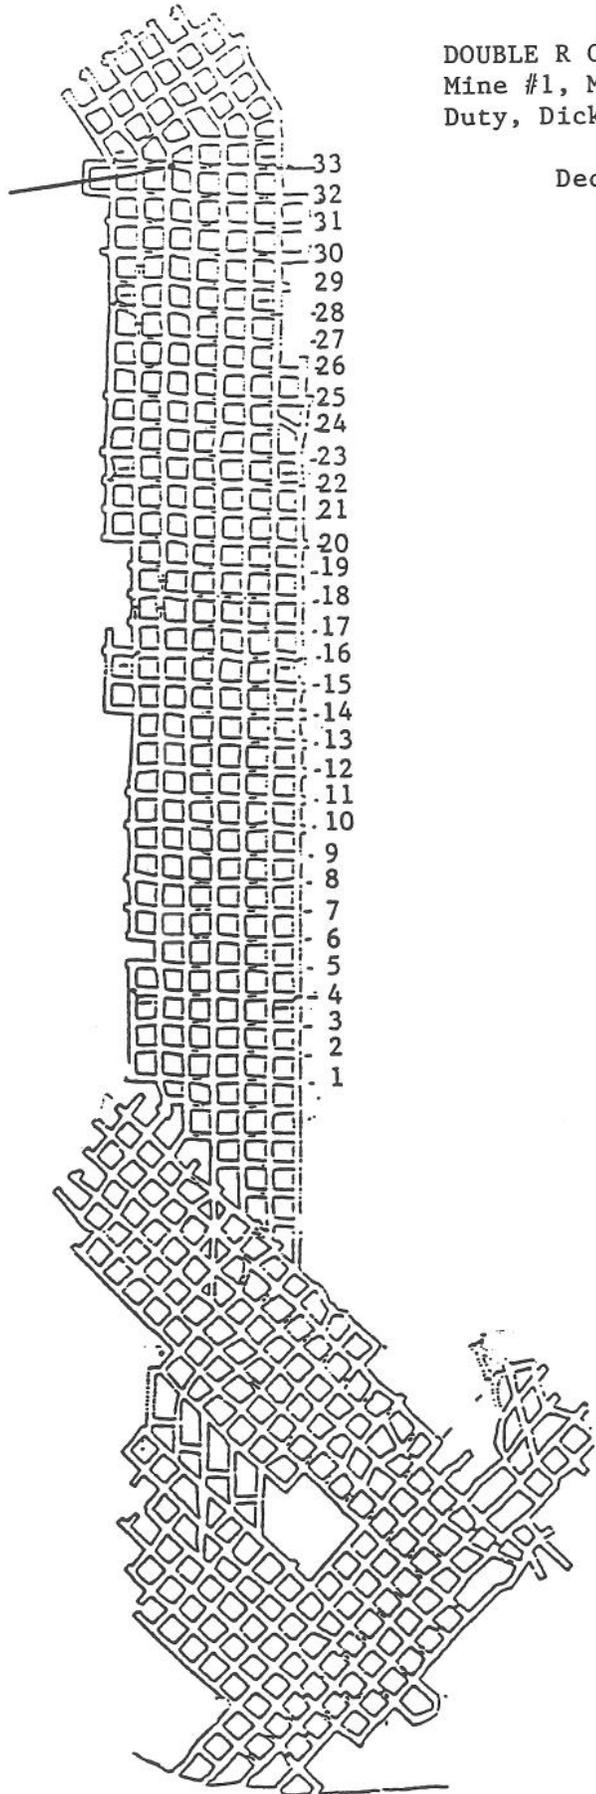
Location where  
Ted C. Street, Victim,  
was found.

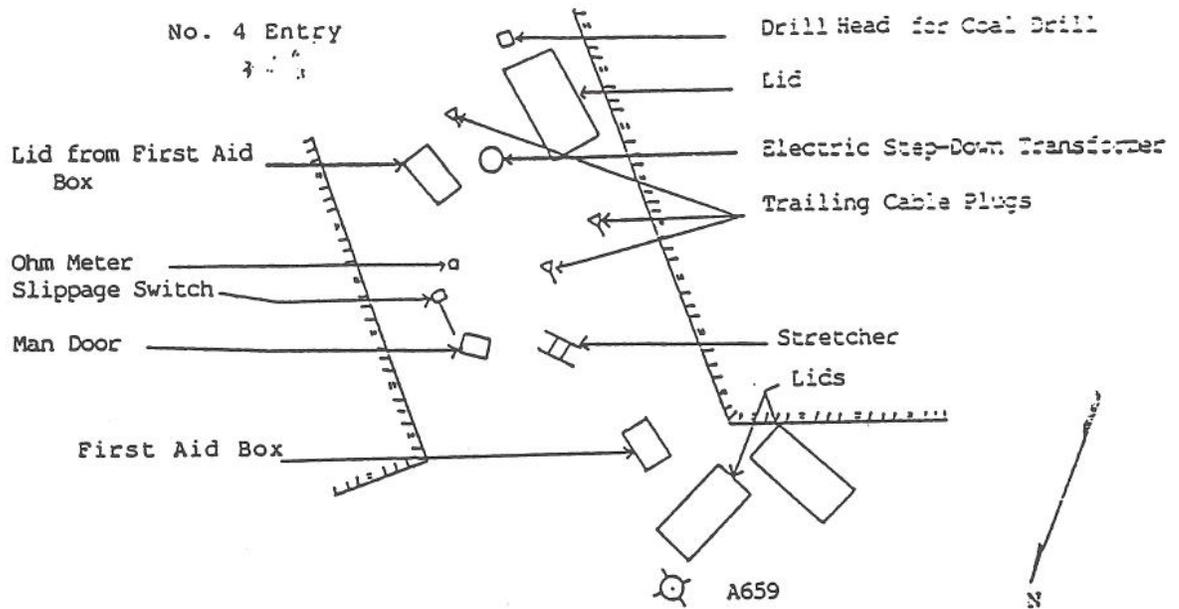
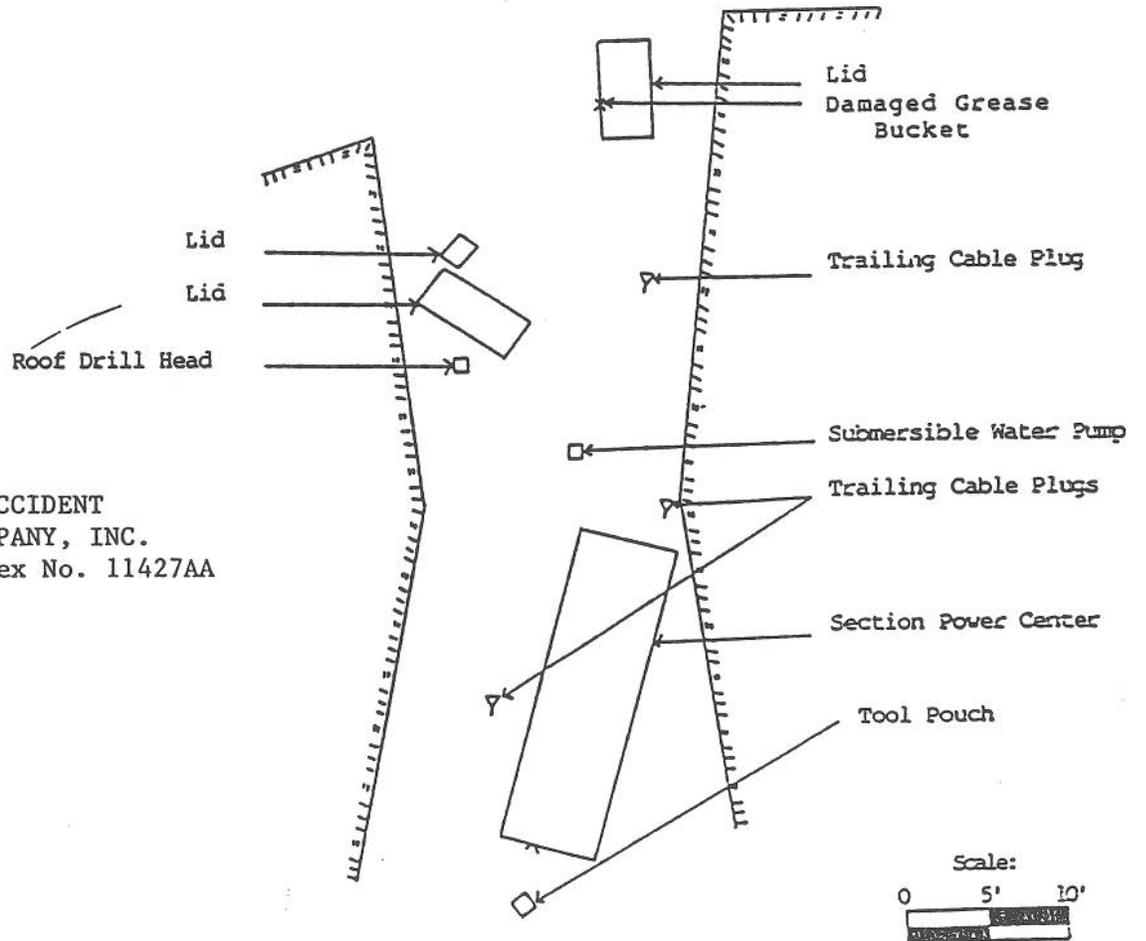
APPENDIX IIF

- A. All trailing cables' end plugs were disconnected and blown in the direction of the face,
- B. There was severe damage to the power center with all of the top covers blown in the direction of the face,

- C. The high voltage disconnect switch located in the back of the power center was completely destroyed,
- D. The cover over the high voltage switch was torn off the power center,
- E. The plexiglass inspection cover for the high voltage fuses on the left side of the transformer was broken and melted,
- F. The low voltage panels were torn loose, but were still on the power center,
- G. There was internal damage to the power center, and
- H. The low voltage AC circuit breakers were in the trip position.

The direction of the explosion forces and damage to both ends of the power center indicated that the explosive forces traveled both inby and outby. Although these conditions existed, there was no evidence found to indicate that this power center provided the ignition source for the explosion.
