SAFETY ALERT BULLETIN

Damaged Roof
Pan

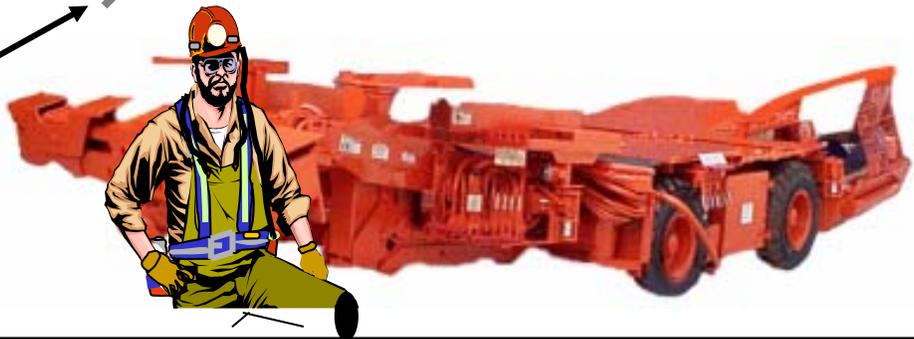
On July 11, 2005 at about 3:15 a.m., a roof bolter operator was attempting to adjust the tilt level on the drill head of a dual boom Fletcher roof bolter. The wrench, he was using, slipped off the drill head lock nut causing his arm to strike the jagged edge of a roof pan that had been damaged by other mining activity. The roof bolter operator sustained a laceration to his right upper arm near his elbow and required surgery to repair the muscle.

- Always check the area for possible hazards before performing work.
- Ensure adequate clearance is available prior to performing work in all areas of the mine.
- Deformed roof caps should be repaired to prevent hazards to workers.
