FATAL ACCIDENT: August 2015

Miner Engulfed After Silo Structural Failure

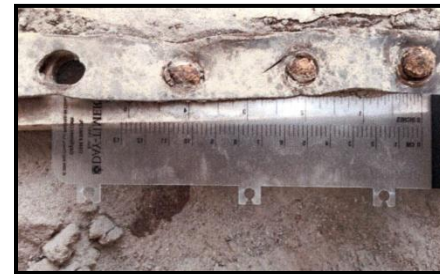
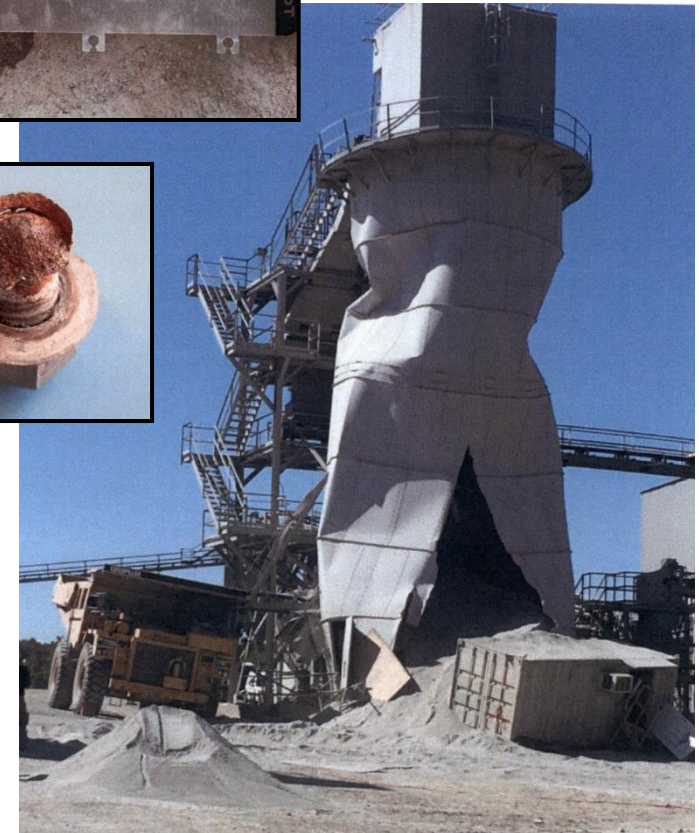
On August 3, 2015, an eighteen-year-old miner with nine weeks of mining experience was engulfed and buried by the contents of a silo. He was working beneath the structure at the time. The silo collapsed when the inner-cone section failed suddenly and fell, causing the silo walls to split open and the contents to spill out. Emergency medical and technical rescue teams responded immediately to locate and rescue the miner. The initial rescue and recovery attempts were temporarily suspended to stabilize the collapsed silo structure and reduce safety hazards for the rescue workers. Rescue and recovery efforts resumed once the structure was stabilized and the victim's body was recovered on August 4, 2015.

- The accident occurred because the silo structure was not maintained in a safe condition. The heads of a significant number of the bolts that connected the discharge hopper were exposed to abrasive wear and corrosion resulting in their inability to support the weight of the hopper and the material stored in the silo (note the bolts in the inset pictures at right).

- No internal inspections of the silo and discharge hopper were conducted since it was constructed in 1993. In 2012, an external inspection was performed to gauge metal thicknesses at multiple areas of the silo and discharge hopper walls. As a result of this inspection, modifications were made to reduce wear on the silo walls. No follow-up inspections of the wear areas or metal thicknesses were performed.

- Recommendations:
 - All structures should be inspected on a regular schedule to assess wear, corrosion, or damage that could affect the safety of miners working on, in, or around them.

- Mine employees should be trained to identify defects. Any defects found should be reported immediately to the certified mine foreman or mine operator and corrective action taken.

- Structures found to contain defects that pose an imminent danger to personnel working in or around them or structures having a serious defect that cannot be corrected immediately should have the entrance to the structure, and the surrounding area that could be affected, properly barricaded to prevent entry and access. The area should have appropriate warning signs posted as well.
