COMMONWEALTH OF VIRGINIA  
DEPARTMENT OF MINES, MINERALS AND ENERGY  
DIVISION OF MINES

DOUBLE R COAL COMPANY, INCORPORATED  
MINE #1  
MINE INDEX NUMBER 11427AA

INVESTIGATION REPORT  
(Underground Coal Mine Explosion)

**December 26, 1987**

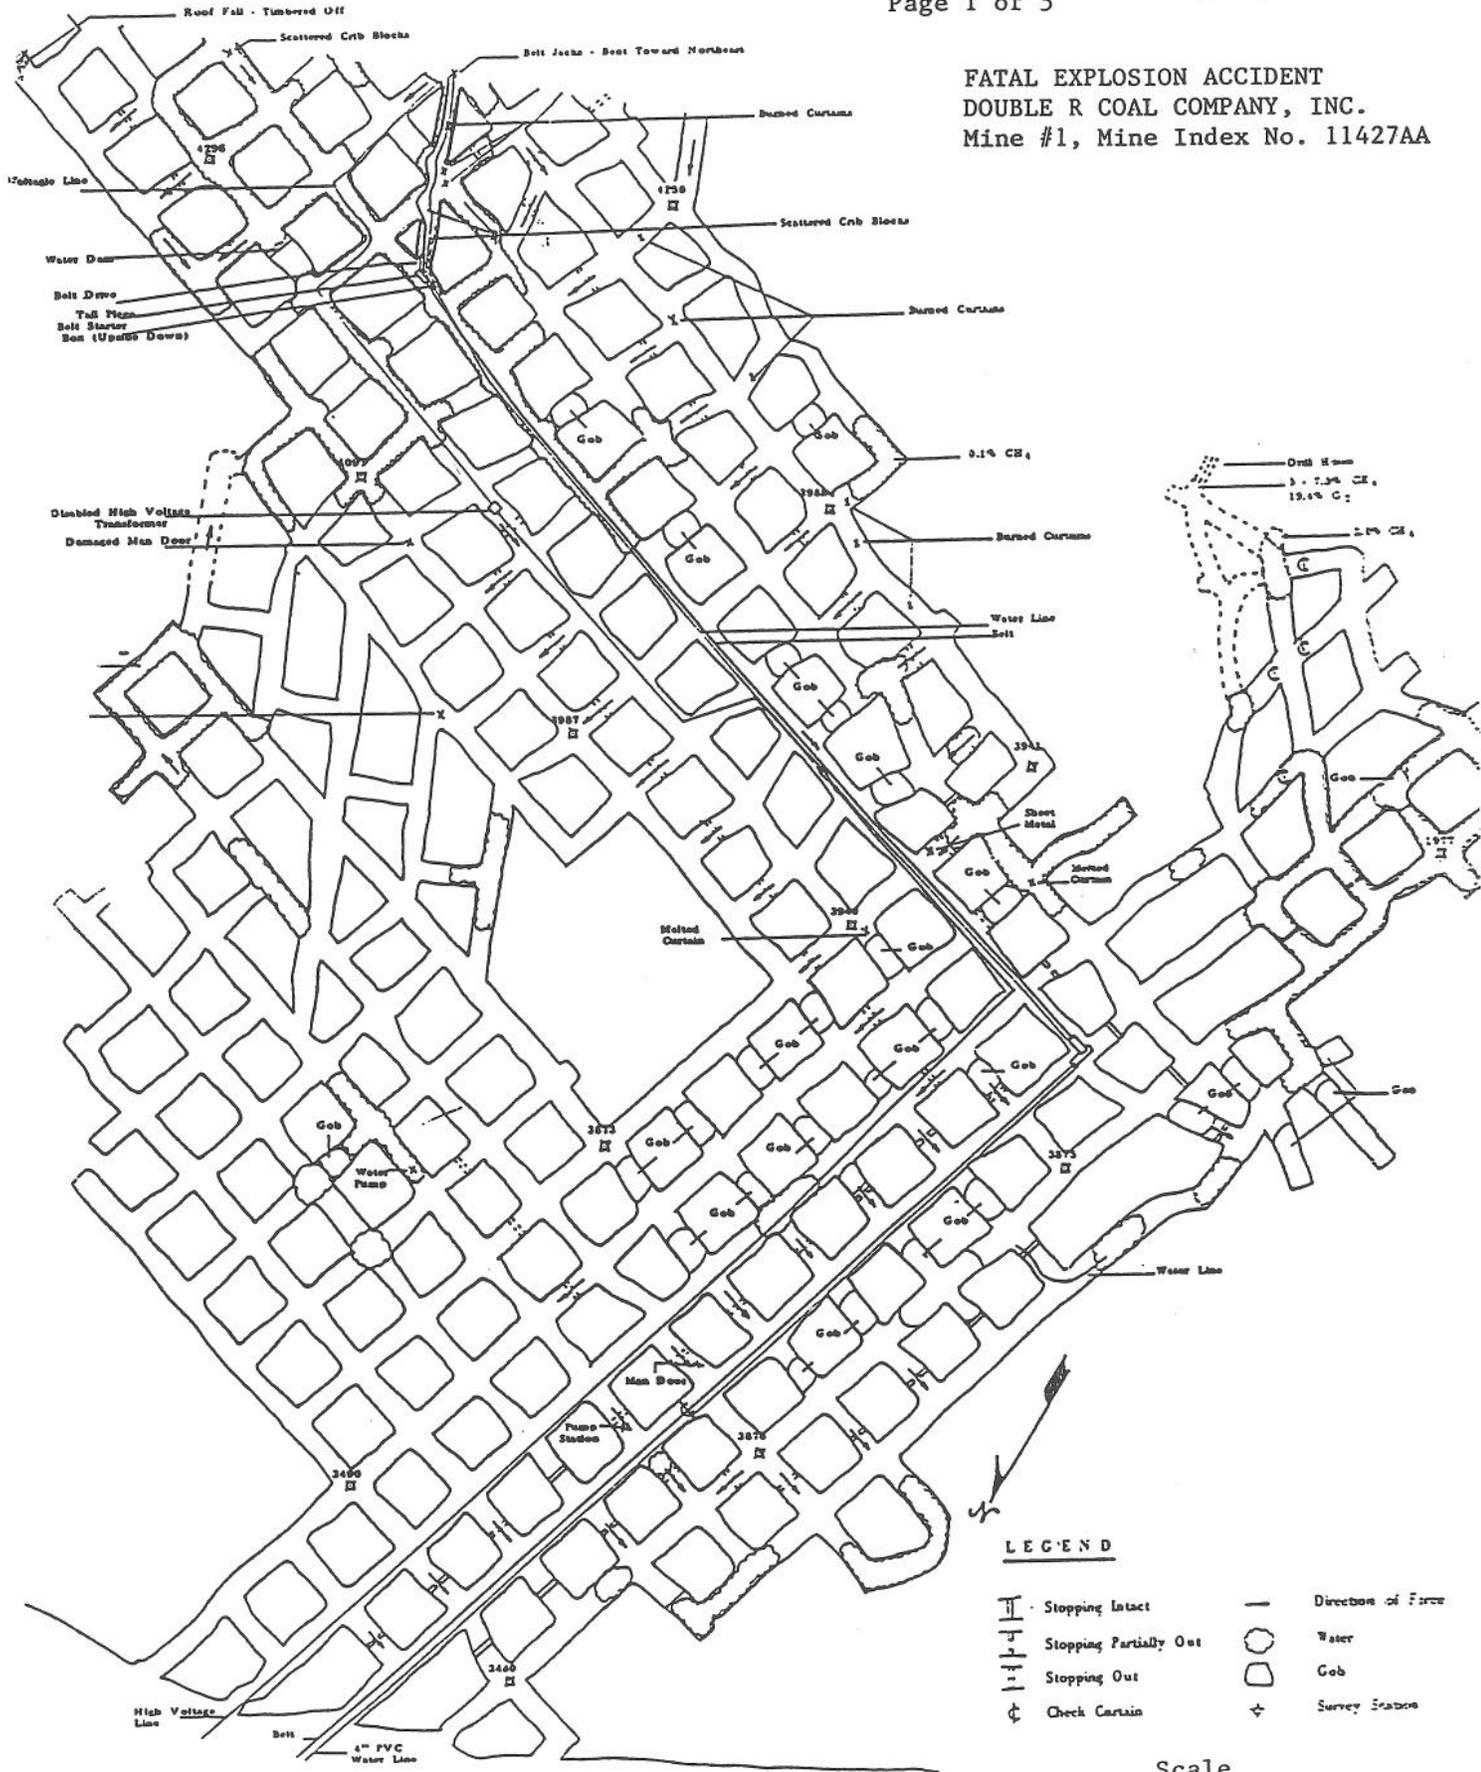
FATAL EXPLOSION ACCIDENT  
DOUBLE R COAL COMPANY, INC.  
Mine #1, Mine Index No. 11427AA

Location where  
Ted C. Street, Victim,  
was found.
