# FATAL ACCIDENT: August 2009

## Customer Pinned Between Truck and Excavator

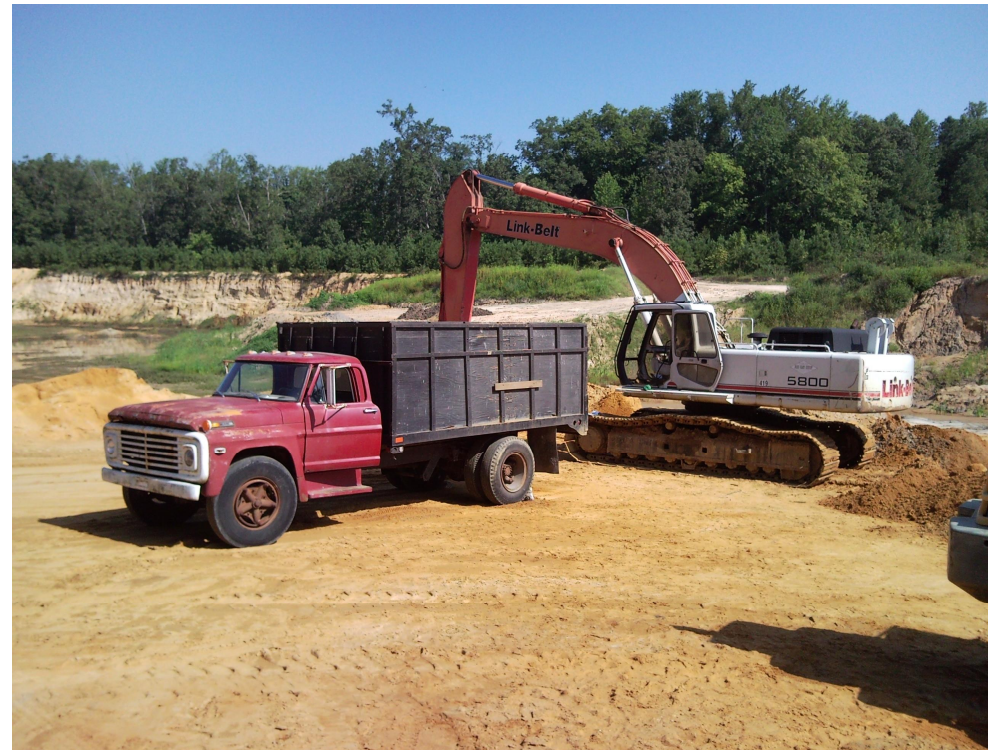
On August 18, 2009, a customer was seriously injured at a sand and gravel mine in Virginia and later died from his injuries on August 22, 2009. The customer, who was a local farmer, drove his “Farm Use Only” truck into the loading area of the pit to pick up a load of sand for use on his farm. After backing up to within 15 feet of the mine excavator, the customer got out of his truck without turning it off or taking any measures to prevent it from moving, and walked over to the excavator to place his order. While he was talking to the excavator operator, the truck rolled backwards, striking and pinning him between the side of the excavator and the rear of the truck. The man was air-lifted to a local hospital where he died four days later from blunt force trauma injuries to his abdomen, chest and neck.

DMM determined that this accident occurred because:

- The victim parked on a grade and left his vehicle unattended without setting the brake or blocking it to prevent it from moving.
- The victim placed himself in a dangerous position (effectively a pinch point) between two pieces of mobile equipment.

Accident scene after the victim had been removed

To prevent a similar accident from occurring, DMM recommends:

- Vehicles/mobile equipment must not be left unattended unless the brakes are set and, when on a grade, the wheels shall be blocked or turned into a bank (4VAC25-40-1510).
- Persons on the ground must remain clear of mobile equipment (4VAC25-40-1600).
- Mine operators must ensure that all persons entering the mine site receive hazard training.
- In operations like this, a safety berm should be constructed between the excavator and the truck loading area to act as a stop block preventing the excavator and trucks from coming into contact and creating a pinch point.
